service information

DATE: November 1995 (supersedes S.I. 05/91, December 1994) **REF. NO.** 05/93

SUBJECT: ENGINES 602, 603 AND 606

ENGINE RELATED COMPLAINTS DUE TO STRETCHED TIMING CHAIN

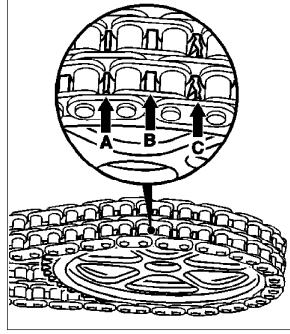
Figure 3 P05-5498-15

Turn the engine 2 complete revolutions (in normal rotation) using the crankshaft pulley bolt and inspect the camshaft sprocket (B, Figure 3 [undamaged tooth]). If the teeth are worn (A) or broken (C) the camshaft sprocket and injection pump timing sprocket must be replaced (Engine 602/603 SMS, Job No. 07.1-240) or (Engine 606 SMS, Job 07.1-8014) along with the timing chain.
