Diagnosis - Complaint Related Diagnostic Chart - Overall Function

Diagnosis - Complaint Related Diagnostic Chart - ATF Leak Complaints (Individual)

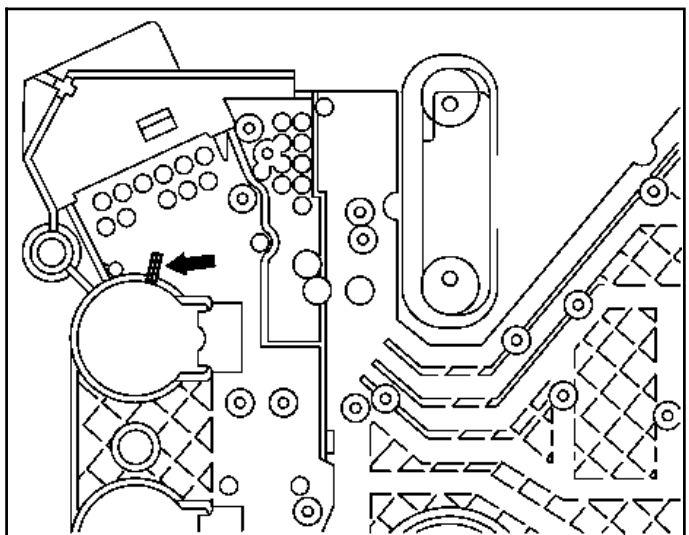
Figure 1

V	Complaint/Problem	Possible cause	Test step/Remedy ¹⁾
--	ATF oil leak near electro-hydraulic control unit connector i Prior to starting any repairs, check the ATF fluid level.	Distorted O-rings Distorted connector The electrical conductor plate is not resting properly on the valve body housing. Therefore, the connector is not properly centered in the bore of the support plate and does not seal completely around its circumference. Electrical connections at the electrical conductor plate are leaking ATF. Therefore, ATF leaks into in harness, at times to ETC control module (N15/3).	Replace O-rings i Applies up to transmission number 1211278 only, thereafter modified material used (color: red/brown). Replace connector. i Applies up to transmission number 1309692 only, thereafter modified material used. Carefully remove boss on the electrical conductor plate (Figure 1, next page, arrow), to allow proper seating. i Applies only between 09/97 and 02/98, up to transmission number 77692 only. Replace the following components: electrical conductor plate, connector and O-rings.

Valve unit (Y3/6)

(sectional, as seen from below)

(**arrow**, remove boss in electrical conductor plate)
