# IGNITION MISFIRE MB CIS-e Engines

Mercedes-Benz M119, M104 and M103 Continuous Injection System (CIS-e) engines with electronic ignition from the early 1990's were known for difficult-to-diagnose problems with engine hesitation and misfiring.

This article describes my DIY research and testing to try to establish, once and for all, the factors behind the misfire problem on my 1992 500SL. Various solutions are examined, aimed at promoting ventilation, dispersal and also exclusion of the water vapour inside the distributor caps.

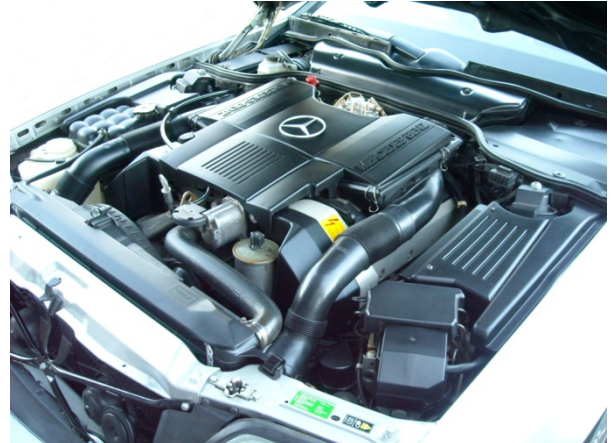
One of the main causes of this type of misfiring is moisture in the distributors, which condenses on the inner surface of the cap(s), causing arcing between the high tension poles, leaving the tell-tale carbon tracking on the inside of the cap(s). Typical remedies involve either regular cleaning or costly replacement of the distributor caps.

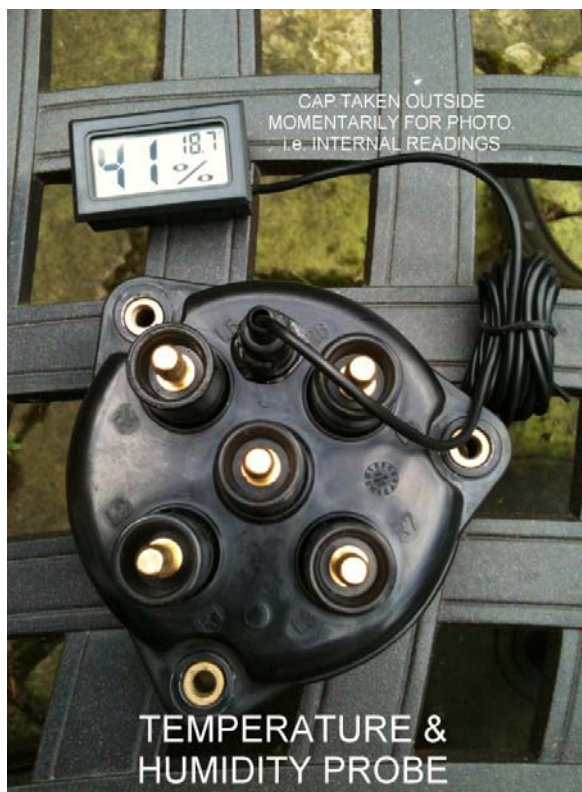
**Figure 2 Hygrometer/Thermometer**

An 8mm diameter hole was drilled through the top of the distributor cap midway between two of the high tension poles and a small hygrometer and temperature remote sensor was glued in place to enable direct readings to be measured of the relative humidity (RH%) of the air inside the distributor and the temperature of the cap against time while the engine was idling and warming up.

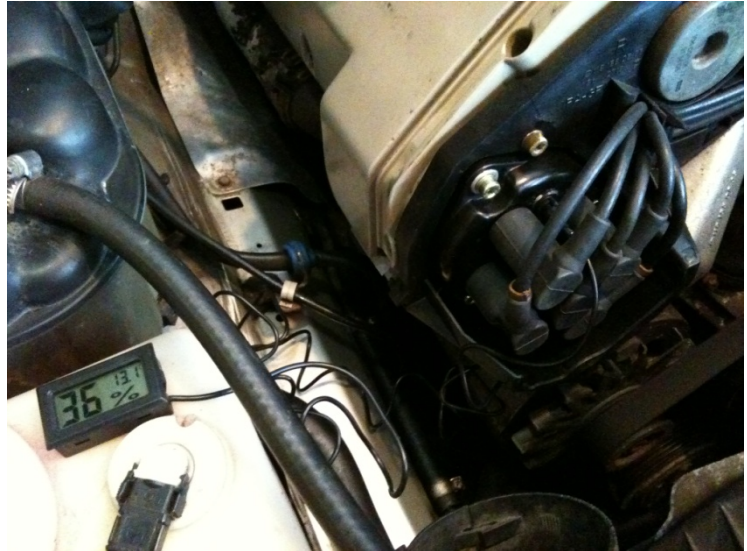
**Figure 4 Live Recording**

At the beginning of each test the ambient relative humidity, temperature and barometric air pressure were recorded.

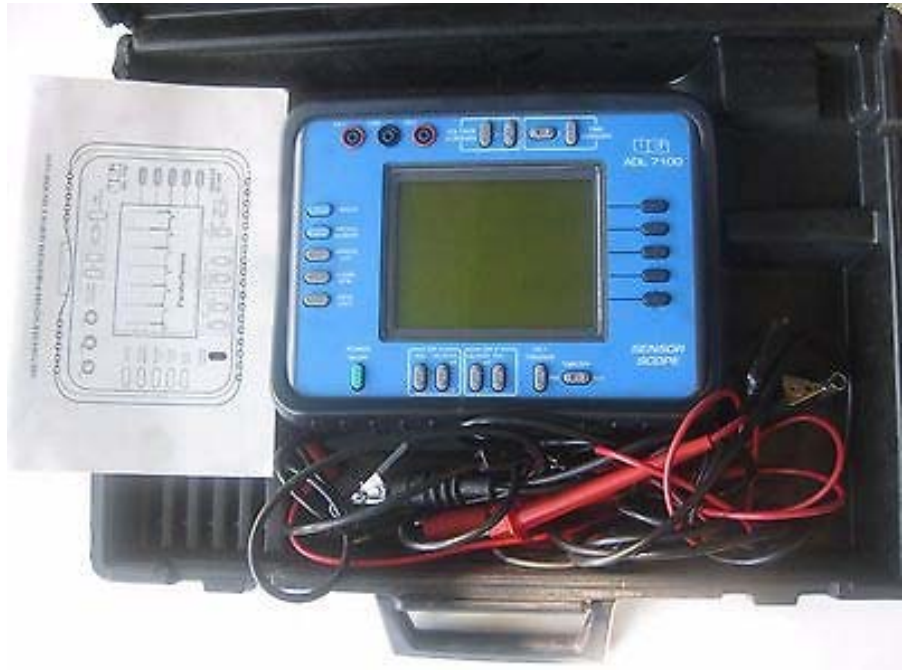
**Figure 9 Lab Scope**

Bandwidth: DC to 5 MHz (-3dB)

Sample rate : 25 Mega samples/second

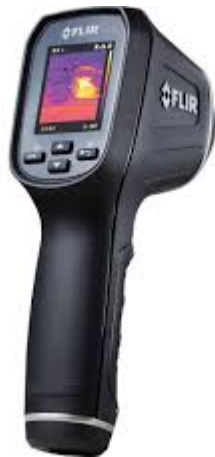
FLIR TG 165 Infra-red thermal imaging camera with digital readout.

Basic accuracy:  $\pm 1.5\%$  or  $\pm 1.5^{\circ}\text{C}$

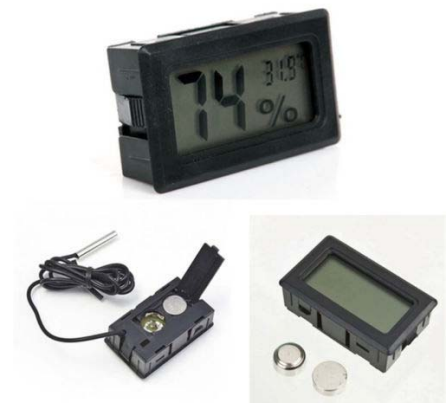
**Figure 11 Hygrometer/Temperature Probe**

Digital LCD Thermometer Hygrometer Temperature Humidity Indoor Meter Probe.

Dimension: 48 x 28.5 x 15.2mm

LCD Dimension: Approx. 40 x 22.5mm

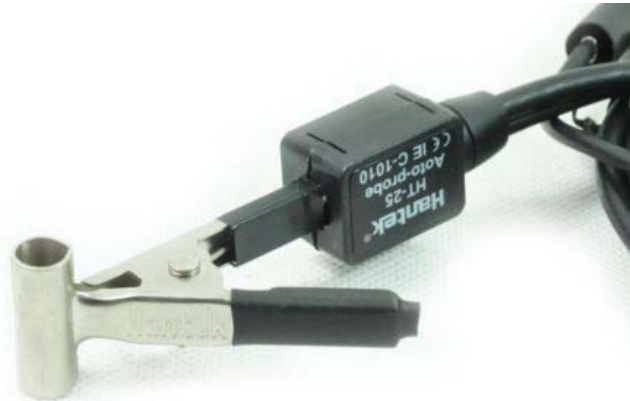
**Figure 12 Capacitance Pickup**

Secondary ignition  
capacitive pickup  
probe

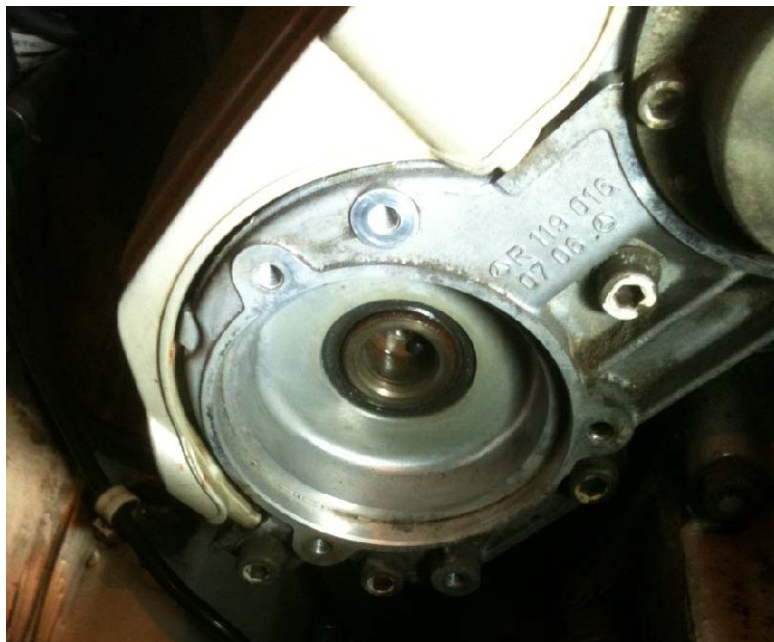
**Figure 37 Camshaft Seal**

If the cam seals are worn, you might expect some oil and crankcase pressure leakage. However new or correctly working seals will prevent crankcase gases from passing.

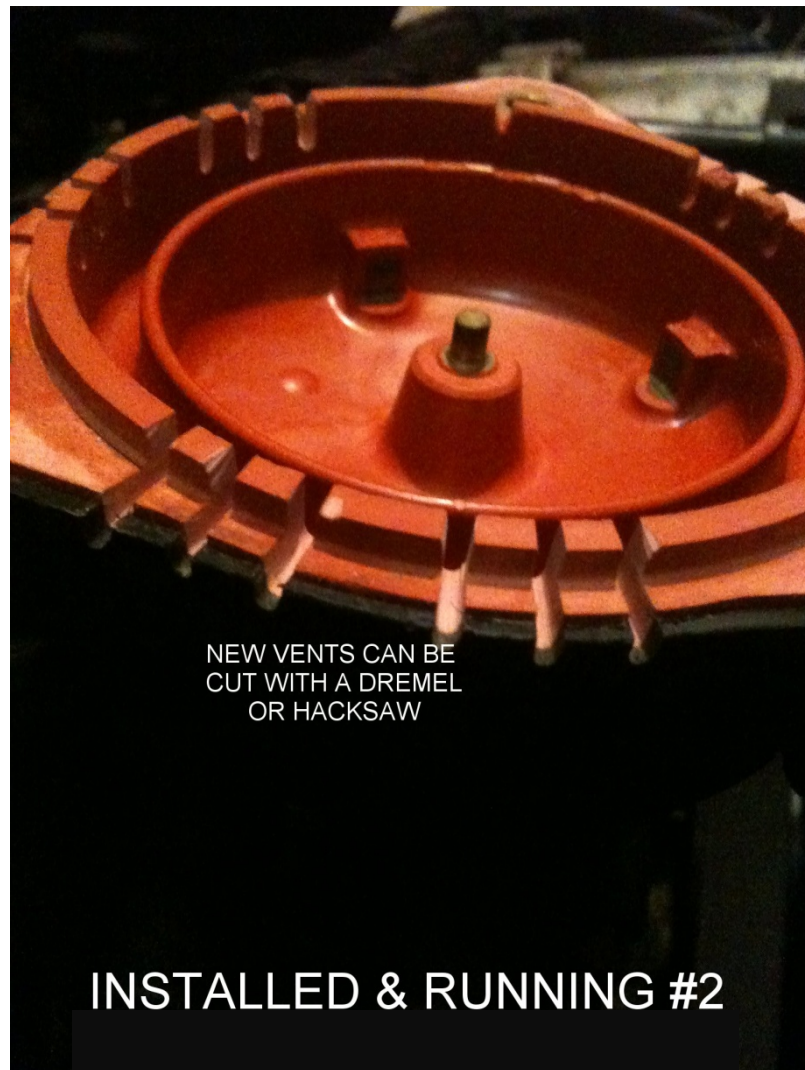
**Figure 41 Modified Distributor Cap - Type 2 - At 6 months During Road Test - 1500 Miles**

The new vents were cut with a Dremel cutter in order to achieve a neat result.

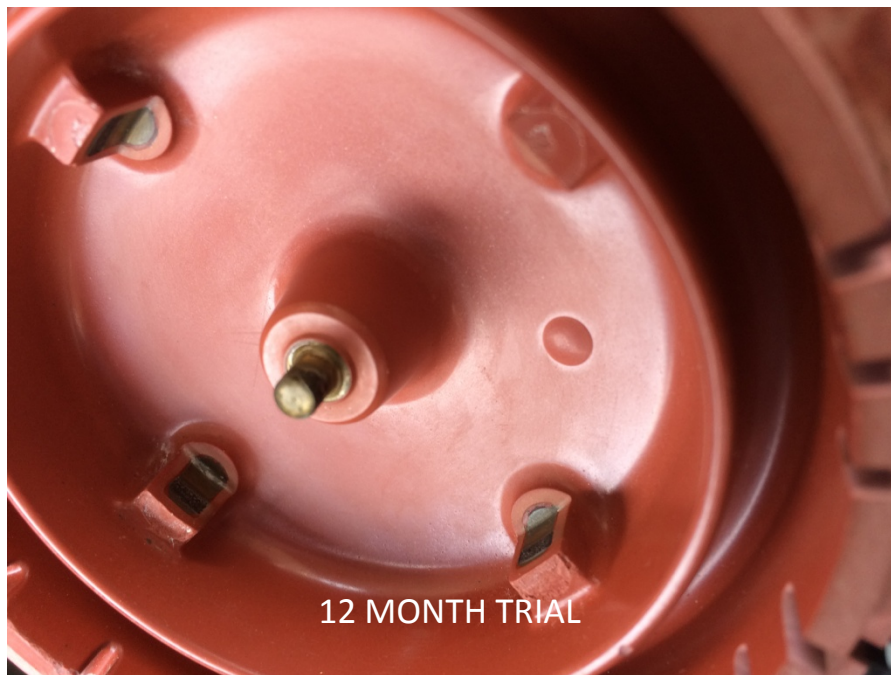
**Figure 42 Modified Distributor Cap - Type 2 - At 12 months During Road Test - 3000 Miles**

The photos below depicts the inside of the distributor cap after 12 months and approximately 3000 miles.

So far the results of the 12 month 3000 mile road test are very positive and they align well with the theoretical predictions.

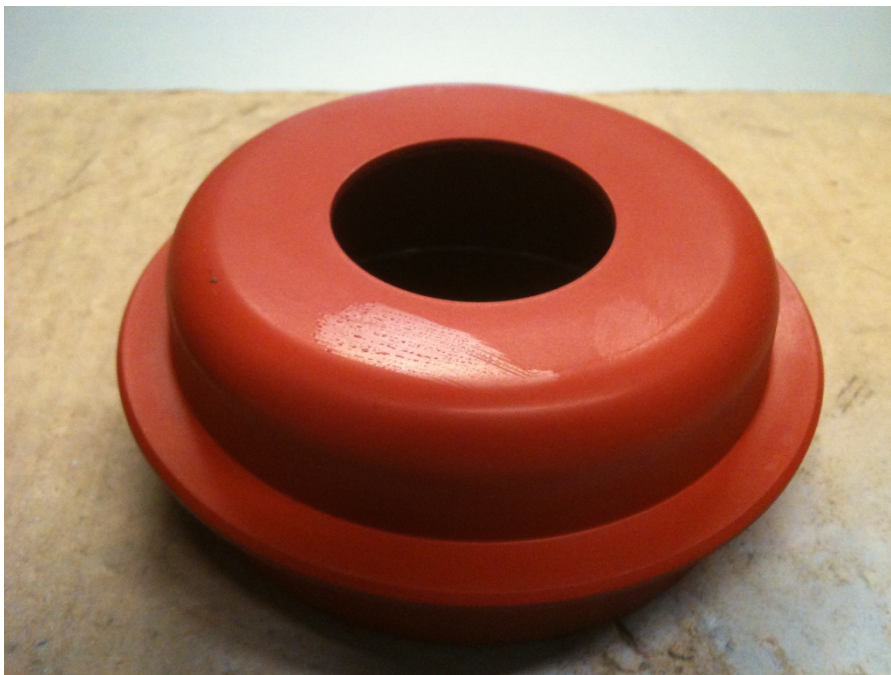
**Figure 50 Condensation Reverse Side of Insulator Cup**

To illustrate the fact that moisture vapour can still condense on the insulator cup, the photo of the insulator cup below shows condensation on cup. It was removed from the vehicle and photographed quickly to capture the moisture on the surface before it evaporated.

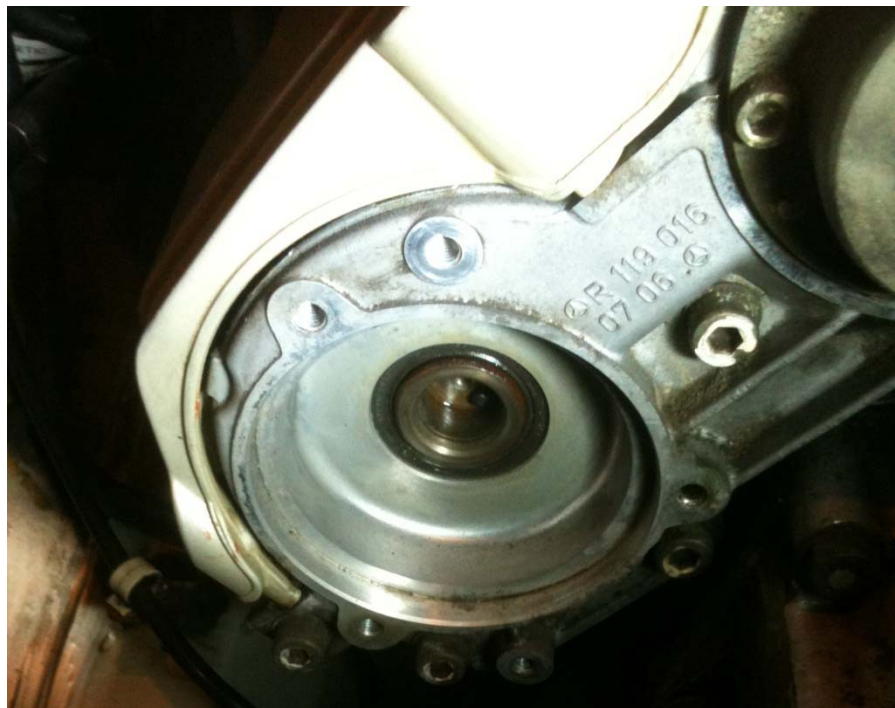
**Figure 51 Photo of Alloy Recess (No Corrosion)**

I am also left with the question: If, without the silicone grease, water vapour is claimed to accumulate in the gap between the alloy recess and insulator cup, why are there no signs of corrosion of the alloy recess?

In conclusion, for those of us living in more humid areas (65% to 95%) I would recommend the additional air vent method first, and if this fails to work, you could try applying the silicone grease as a last resort in combination with the vents.

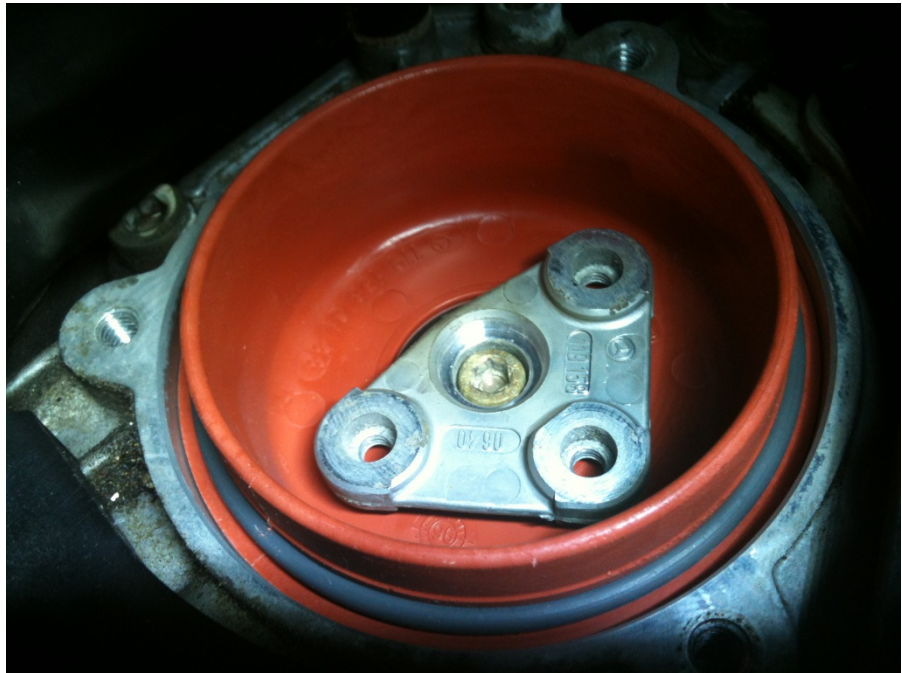
**Figure 53 Insulator Cup**

The insulator cups are very expensive for what they are, and in my experience this suggests that Mercedes-Benz did not anticipate these would be normal service parts, which is probably reflected in the very high unit price. They do not need to be changed UNLESS there is obvious carbon tracking, or the cup has been affected by heat and moisture. The way to check is by the colour. The cups start out a red colour. When moisture is adsorbed into the molecular structure of the cup the cups gradually change colour from red to pink to orange to yellow. Although I have seen dark brown coloured versions, but not on R129s.

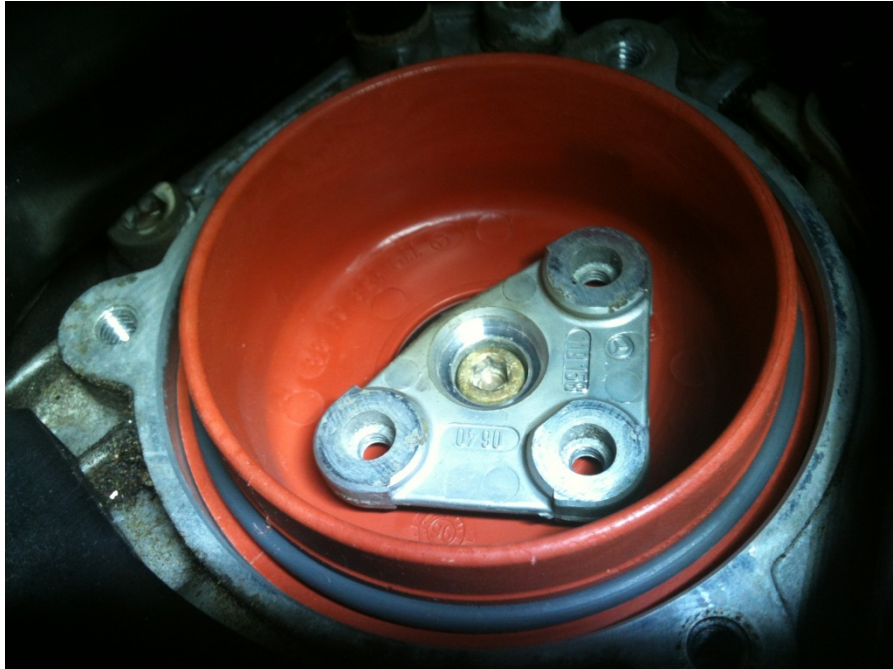
**Figure 56 Insulator Cup O-Ring**

Within the distributor cap there is an o-ring seal attached to the insulating cup. The insulating cup is designed to prevent the distributor from shorting to ground, and promotes a compact distributor design.

The o-ring has elastic characteristics that accommodate the thermal expansion and contraction of the cup, while ensuring that the cup remains seated and does not rattle about. As far as I can see the cup is not a dust cover, although it is referred to as a dust cover on various distributors internet catalogues, which is not correct.
